CONDITION SURVEY OF LOCK NO. 8, MONONGAHELA RIVER

Richard L. Stowe

June 1987

Prepared for US Army Engineer District, Pittsburgh
Pittsburgh, Pennsylvania 15222-4186

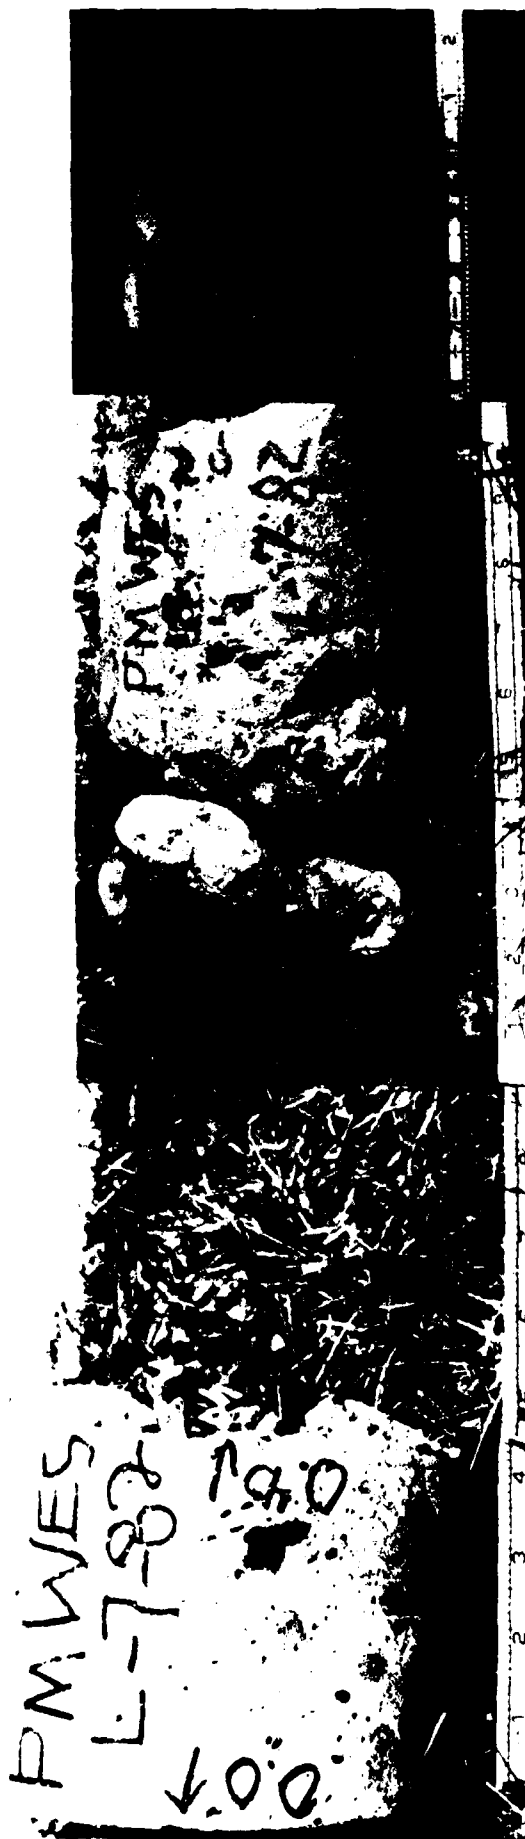
Concrete core, boring L-7-82, overlay concrete, 0.0 to 0.45 ft, missing rubble and cracked concrete to 2.5 ft

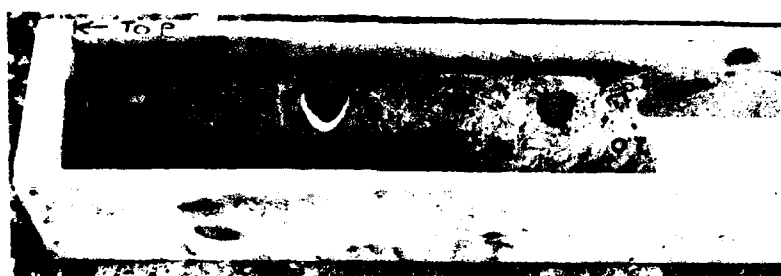
Concrete core boring, L-29-82, high horizontal boring, land lock wall

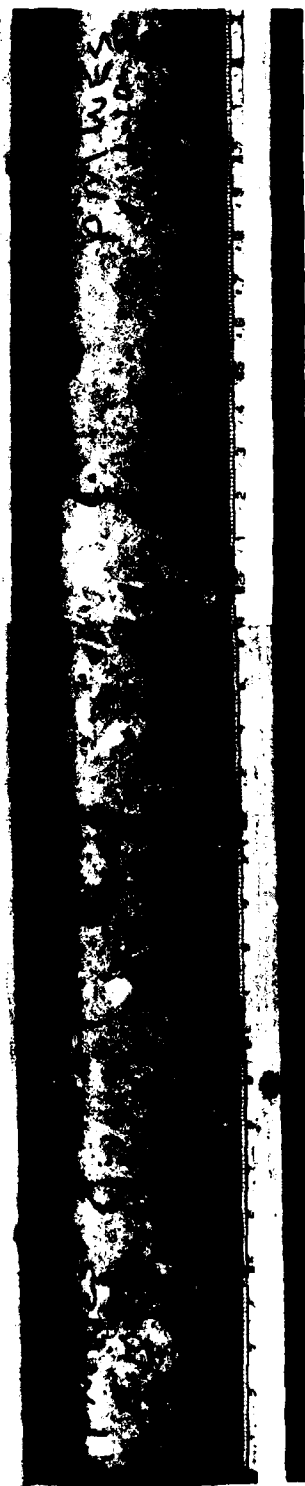
Concrete core, boring L-10-82, vertical boring in upper miter gate monolith
in river wall. No detectable concrete damage

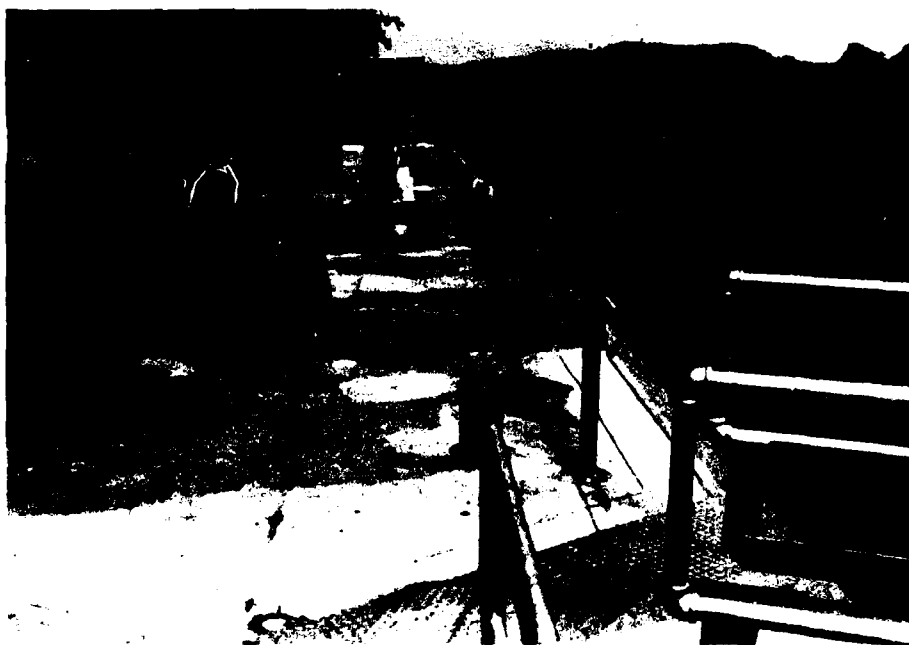
Photo 6. Top surface, lower guide wall, looking downstream

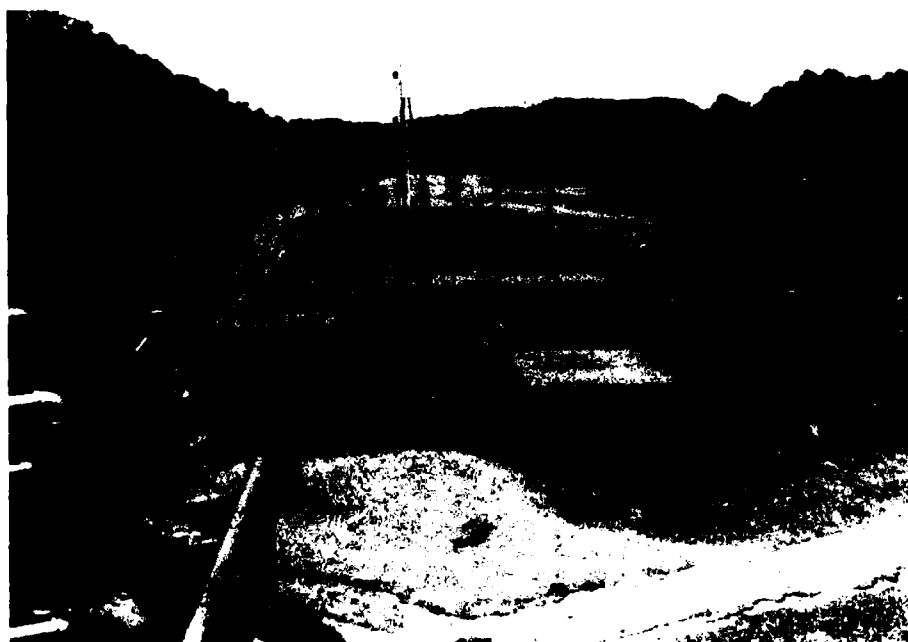
Photo 10. Top surface of the lower guard wall, light concrete areas are patches, looking downstream

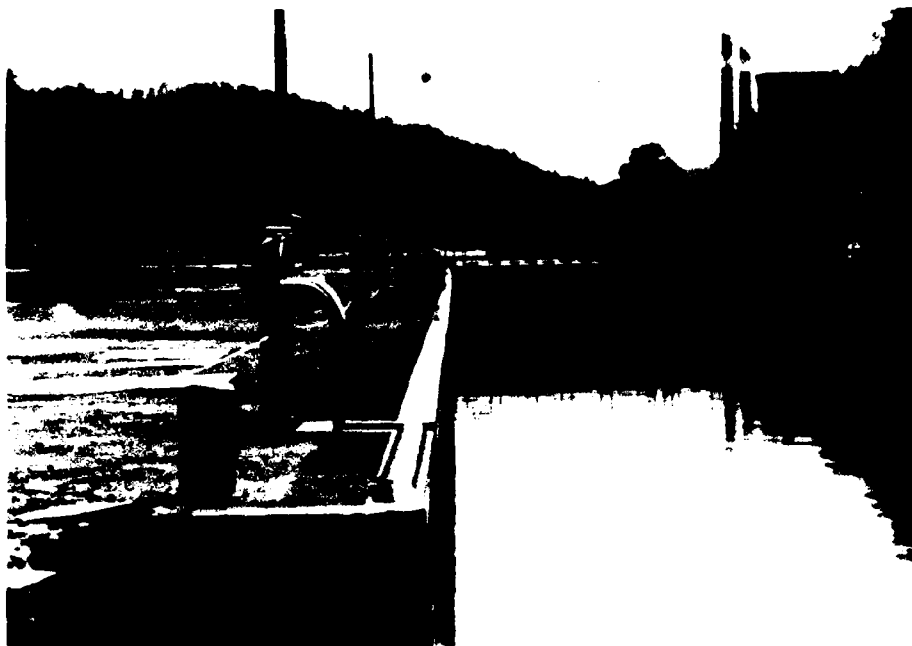
Photo 17. River lock wall showing slight inward bow of the chamber face, looking upstream
